W. Johnson, S. Myers, R. Schepis, J. Crew, R. Keltner

# Zero Leakage Tornado Effect Pumps in Carrier Sewage Systems

This paper is a condensation and combination of two reports that deal with the use of the alternate pump design in aircraft carrier CHT systems. These reports are:

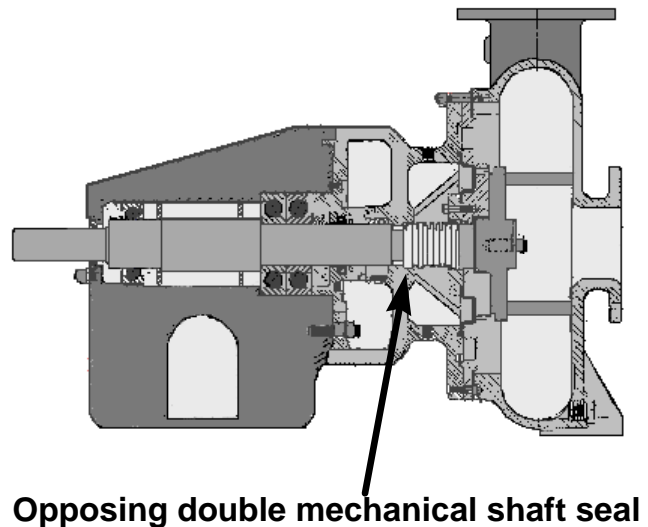
Figure 2. Current CHT pump.

Current CHT pumps employ an opposing double mechanical shaft seal (Figure 2). The sealing faces on each side are constructed of tungsten carbide against carbon. In the cavity or reservoir between the mechanical seals, oil is used as a lubricating substance. In order to keep the mechanical seal faces together, a diaphragm located behind the pump impeller pressurizes the dead-ended reservoir. A coil spring also helps to keep the faces together.

Investigation has shown that the mechanical seal on the pump end is the first to fail, thereby inducing sewage contamination into the pump reservoir. It is believed that when a CHT pump is started, the initial discharge pressure surge may momentarily separate the seal faces on the pump end. The existing carbon seal is too brittle to withstand the repeated chattering of the seal faces or the abrasiveness of the resulting sewage between the seal faces. As the pump reservoir builds up with sewage material, the motor end mechanical seal eventually fails due to contaminated lubrication and allows sewage to leak out into the pump room.

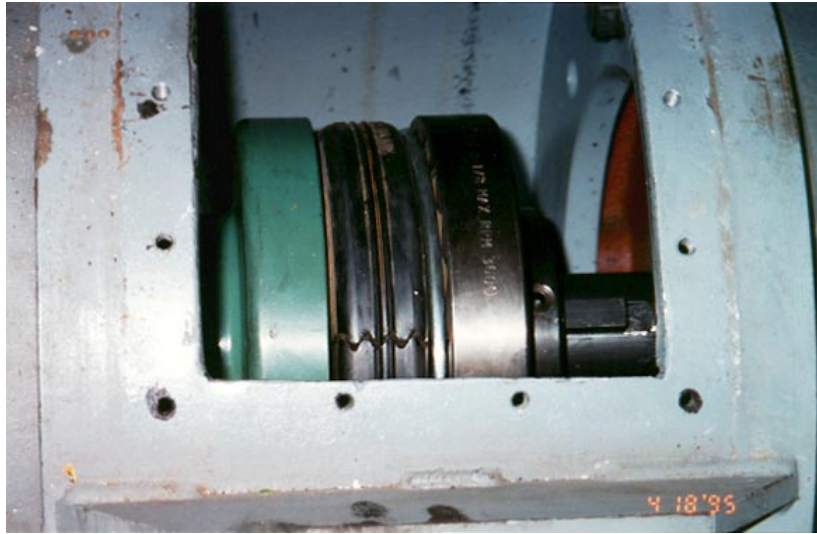
Figure 9. Eddy Pump to motor coupling.

None of the pump components appeared to be corroded, eroded, or worn in any manner. The coupling (Item 13 of Figure 3 and shown assembled in Figure 9 and disassembled in Figure 10) was of particular interest since the rubber portion is considered a replaceable wear item. However, all coupling components appeared to be in nearly pristine condition.

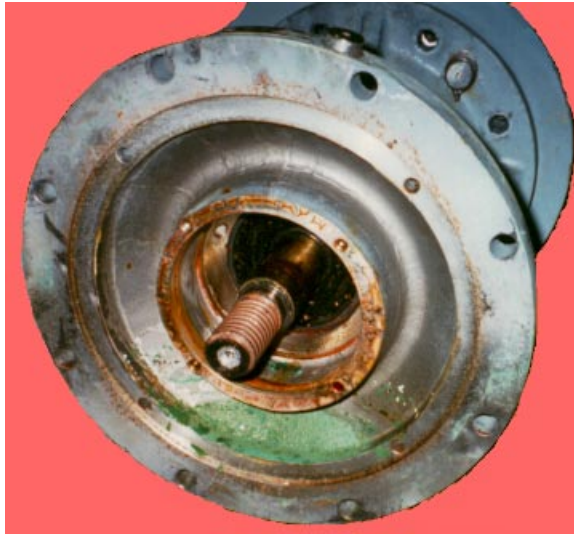
There was some evidence of leakage found in the housing behind the seal plate (Figure 11). A green deposit (in the original color photo) was evident up to the seal assembly, and a smaller deposit inside the seal assembly cavity. The green color implies a copper-based oxidation from water leakage. Overall, however, the leak-by was minimal and the housing had not corroded. Most components in this pump are fabricated from Monel. It is unknown if this minor leak-by occurred during normal pump operation, or from unusual circumstance. The critical factor, in any case, is the water did not migrate fully past the seal and into the pump room. Despite some internal leak-by, the pump maintained zero external leakage integrity overall during the 1,100-hour evaluation period. It is unknown if the pump seal would have suffered a complete compromise over a longer period, and if so, how long that would have taken.

Figure 11. Indications of slight leakage residue.

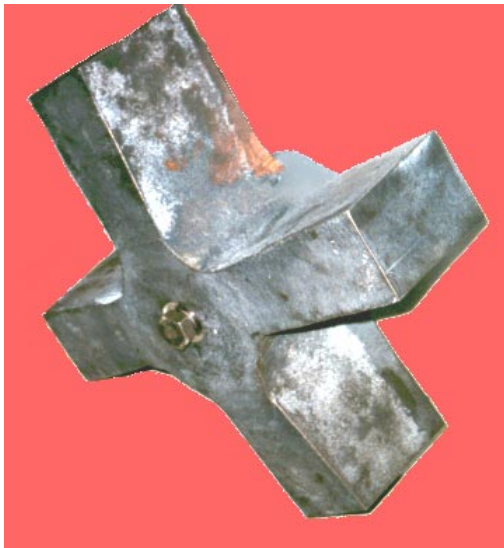
Figure 12. Rotor locking device installed for additional security.

The rotor was removed and taken to the ship's machine shop. There it was modified, at the manufacturer's request, to include a shaft locking bolt. Item 10 of Figure 3 and Figure 12 show the modification. The rotor is screwed onto the threaded shaft (also shown in Figure 11). Once installed, the rotor's friction with these threads is sufficient to secure it. In fact, the fit is so tight that a special rotor removal tool and hammer impacts were needed to loosen it. The locking bolt was added only as an additional insurance measure to preclude loosening when pump direction is reversed as a result of back flow through the discharge CHT piping.

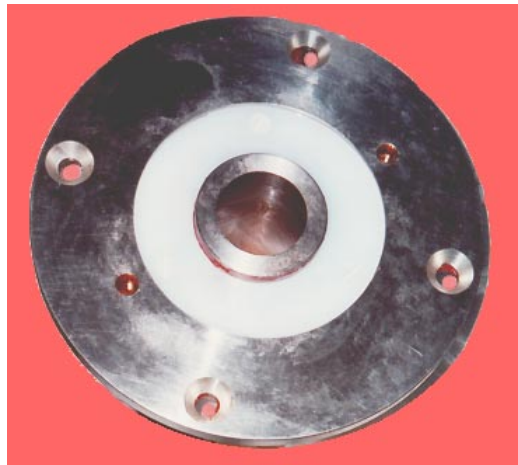
Figure 15. New seal assembly.

The pump was reassembled with a new shaft/bearing assembly (Figure 13). The shaft is inserted from the rear of the housing (Figure 14). A new seal assembly was then installed (Figure 15). This step revealed a machining problem with the bearing housing. The cone shaped seal assembly is inserted into the front of the bearing housing. The seal assembly has four threaded holes, which align exactly with corresponding non-threaded holes in the housing. These holes are for the four air and grease fittings (Figure 16 and Items 11 and 12 of Figure 3). Upon seal installation, the holes were found to be misaligned by about one-half degree, which was enough to prevent the fittings installations. Another seal assembly was tried, but the same problem

resulted. The conclusion drawn was that the bearing housing was slightly inaccurate. The housing's holes were reamed and the fittings were successfully installed. The manufacturer stated that he would investigate this problem and fabricate a machining jig to ensure exact hole alignments on future pumps.

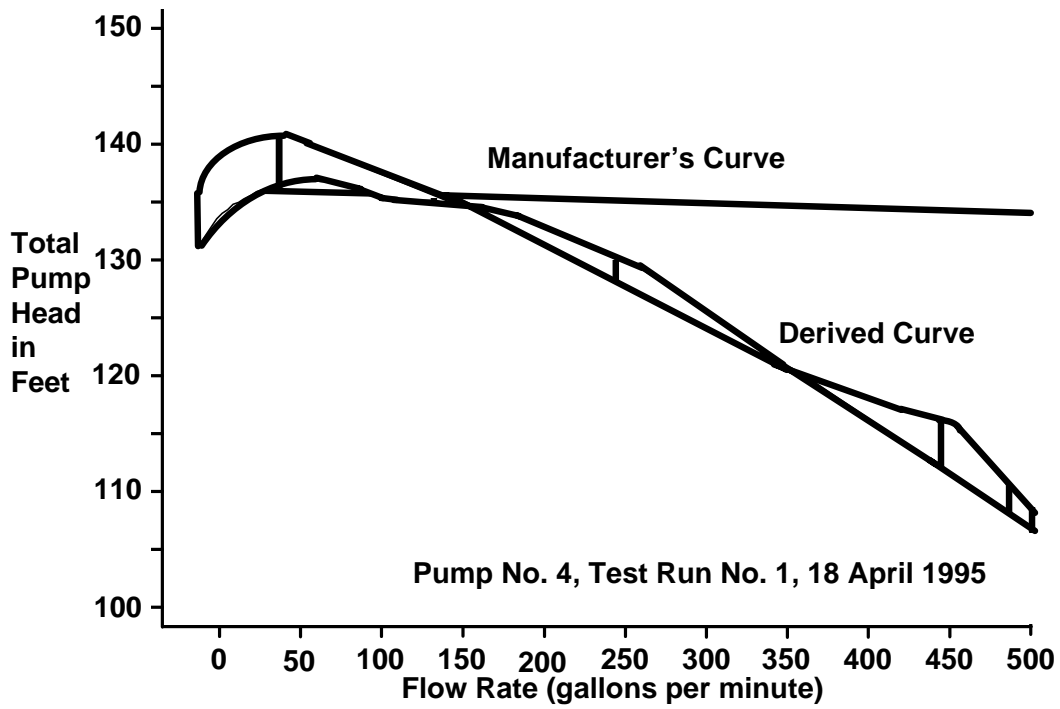
Figure 17. Pump performance curve Run No. 1.

The pump's ability to maintain head pressure at various flow rates is less than expected. The pump's performance matches the manufacturer's curve at low flows (zero to 150 gpm) but it produces about 10 feet less head than expected at 400 to 500 gpm. Despite the lower head pressures at high flow rates, the pump is well suited for this system's configuration. It produced 6 to 7 psig discharge pressure at the deck connection, which is typical of other CHT pumps. The pump performance curves indicate that at-sea testing of the pump should be performed to establish flow rates when the CHT system is shifted to an at-sea lineup, lowering the height of overboard discharge. The lowered height of discharge means lower pump head pressure and increased flow rates. The increase in flow rates may lead to increased piping system erosion.

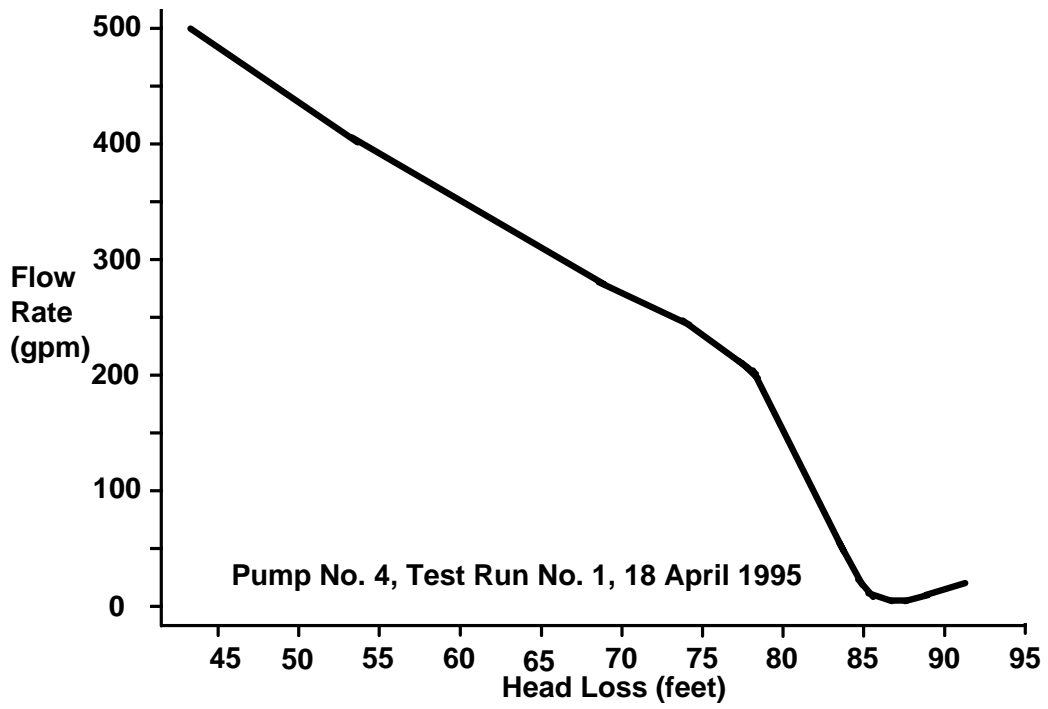
Figure 19. Pump head loss curve Run No. 1.

System friction losses from the pump to deck connection are shown in Figures 19 and 20. Only the average pump discharge gage values were used (rather than the range of readings) to generate these curves. Overall, losses decreased with increasing flow rate. This is because higher flows allow more of the pump's energy to be delivered to the deck connection. At lower flows, more energy (in the form of discharge pressure) builds up at the pump while downstream pressure eventually decreases to zero. The main source of losses at low flows is, of course, the discharge valve as it is progressively closed. The losses determined at full flow are acceptable for this CHT system configuration and Eddy Pump combination since deck connection pressures were adequate. Considering aircraft carrier CHT pump discharge piping configurations as a typical worst case scenario, the pump should provide adequate pressure at the deck connections for most, if not all, currently installed CHT systems.
