W. Johnson, S. Myers, R. Schepis, J. Crew, R. Keltner

Zero Leakage Tornado Effect Pumps in Carrier Sewage Systems

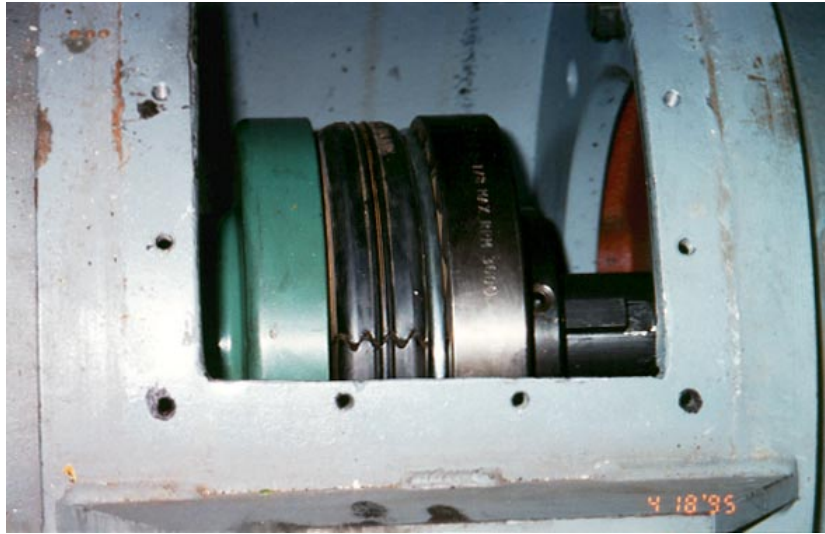
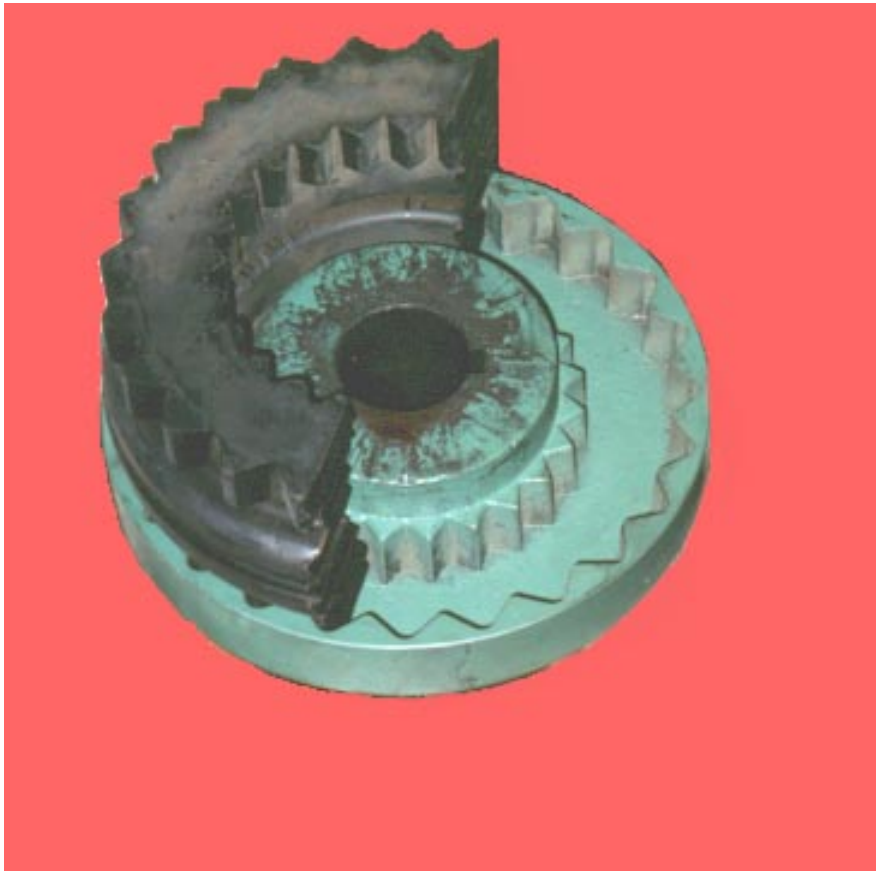
None of the pump components appeared to be corroded, eroded, or worn in any manner. The coupling (Item 13 of Figure 3 and shown assembled in Figure 9 and disassembled in Figure 10) was of particular interest since the rubber portion is considered a replaceable wear item. However, all coupling components appeared to be in nearly pristine condition.

Figure 9. Eddy Pump to motor coupling.

Figure 10. Motor coupling disassembled view.

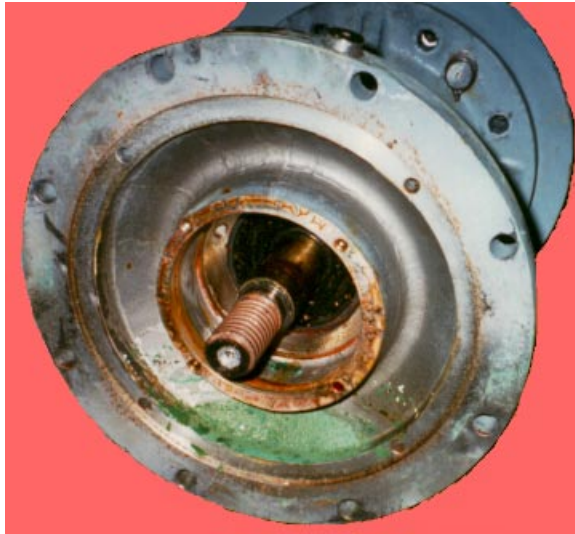
There was some evidence of leakage found in the housing behind the seal plate (Figure 11). A green deposit (in the original color photo) was evident up to the seal assembly, and a smaller deposit inside the seal assembly cavity. The green color implies a copper-based oxidation from water leakage. Overall, however, the leak-by was minimal and the housing had not corroded. Most components in this pump are fabricated from Monel. It is unknown if this minor leak-by occurred during normal pump operation, or from unusual circumstance. The critical factor, in any case, is the water did not migrate fully past the seal and into the pump room. Despite some internal leak-by, the pump maintained zero external leakage integrity overall during the 1,100-hour evaluation period. It is unknown if the pump seal would have suffered a complete compromise over a longer period, and if so, how long that would have taken.

Figure 11. Indications of slight leakage residue.

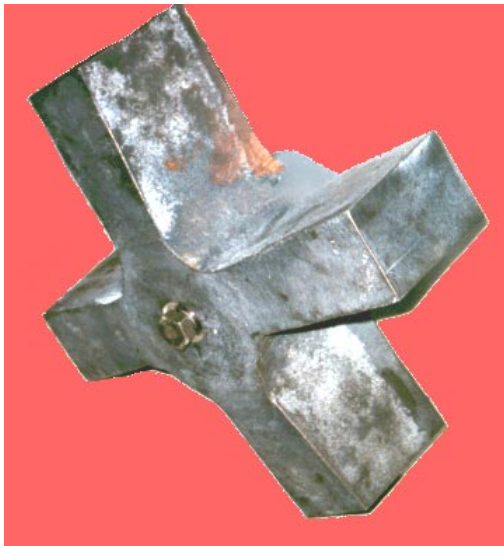
Figure 12. Rotor locking device installed for additional security.

The rotor was removed and taken to the ship's machine shop. There it was modified, at the manufacturer's request, to include a shaft locking bolt. Item 10 of Figure 3 and Figure 12 show the modification. The rotor is screwed onto the threaded shaft (also shown in Figure 11). Once installed, the rotor's friction with these threads is sufficient to secure it. In fact, the fit is so tight that a special rotor removal tool and hammer impacts were needed to loosen it. The locking bolt was added only as an additional insurance measure to preclude loosening when pump direction is reversed as a result of back flow through the discharge CHT piping.

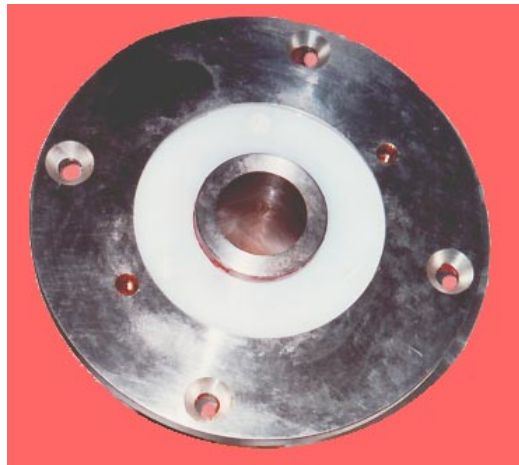
Figure 15. New seal assembly.

The pump was reassembled with a new shaft/bearing assembly (Figure 13). The shaft is inserted from the rear of the housing (Figure 14). A new seal assembly was then installed (Figure 15). This step revealed a machining problem with the bearing housing. The cone shaped seal assembly is inserted into the front of the bearing housing. The seal assembly has four threaded holes, which align exactly with corresponding non-threaded holes in the housing. These holes are for the four air and grease fittings (Figure 16 and Items 11 and 12 of Figure 3). Upon seal installation, the holes were found to be misaligned by about one-half degree, which was enough to prevent the fittings installations. Another seal assembly was tried, but the same problem

resulted. The conclusion drawn was that the bearing housing was slightly inaccurate. The housing's holes were reamed and the fittings were successfully installed. The manufacturer stated that he would investigate this problem and fabricate a machining jig to ensure exact hole alignments on future pumps.

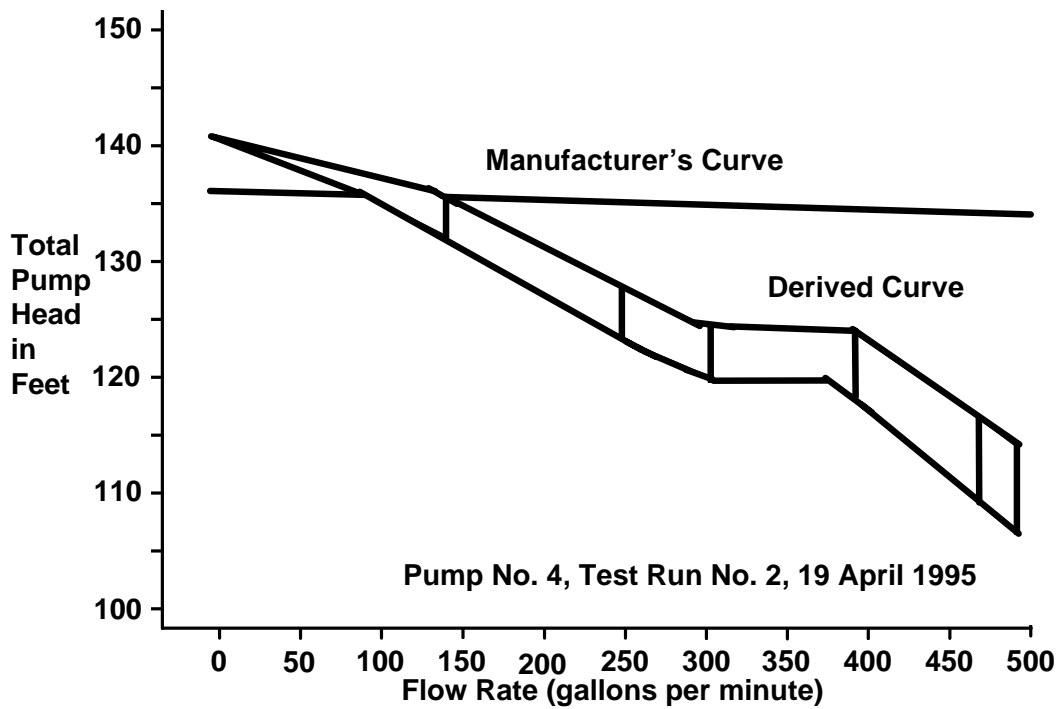
Pump performance curves were constructed from the data collected during the two test runs (Figures 17 and 18). The pump performance curves are shown with comparisons to the manufacturer's curve. The curves have been smoothed to give a best fit to the data. To approximate the manufacturer's curve, it is shown as a straight line ranging from 136 feet of head pressure at zero gpm to 135 feet of head pressure at 500 gpm. The derived curves actually span an area to account for inherent gage errors and the fact that the pump discharge gage needle oscillated during the tests. The span of discharge pressures readings resulted in a range of total pump head calculations for each flow rate. The shaded areas in each curve reflect these ranges. Vertical lines in the shaded areas indicate flow rates at which measurements were taken. Dots show the mean head pressures calculated.

The pump's ability to maintain head pressure at various flow rates is less than expected. The pump's performance matches the manufacturer's curve at low flows (zero to 150 gpm) but it produces about 10 feet less head than expected at 400 to 500 gpm. Despite the lower head pressures at high flow rates, the pump is well suited for this system's configuration. It produced 6 to 7 psig discharge pressure at the deck connection, which is typical of other CHT pumps. The pump performance curves indicate that at-sea testing of the pump should be performed to establish flow rates when the CHT system is shifted to an at-sea lineup, lowering the height of overboard discharge. The lowered height of discharge means lower pump head pressure and increased flow rates. The increase in flow rates may lead to increased piping system erosion.

Figure 17. Pump performance curve Run No. 1.

Figure 18. Pump performance curve Run No. 2.
