W. Johnson, S. Myers, R. Schepis, J. Crew, R. Keltner

# Zero Leakage Tornado Effect Pumps in Carrier Sewage Systems

This paper is a condensation and combination of two reports that deal with the use of the alternate pump design in aircraft carrier CHT systems. These reports are:

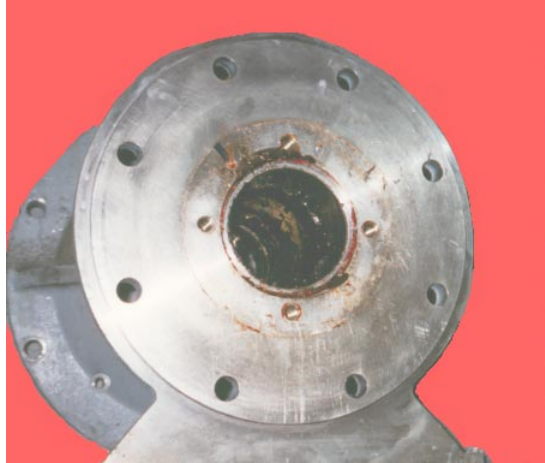
Figure 14. End housing of Eddy Pump.

The pump was reassembled with a new shaft/bearing assembly (Figure 13). The shaft is inserted from the rear of the housing (Figure 14). A new seal assembly was then installed (Figure 15). This step revealed a machining problem with the bearing housing. The cone shaped seal assembly is inserted into the front of the bearing housing. The seal assembly has four threaded holes, which align exactly with corresponding non-threaded holes in the housing. These holes are for the four air and grease fittings (Figure 16 and Items 11 and 12 of Figure 3). Upon seal installation, the holes were found to be misaligned by about one-half degree, which was enough to prevent the fittings installations. Another seal assembly was tried, but the same problem
