W. Johnson, S. Myers, R. Schepis, J. Crew, R. Keltner

Zero Leakage Tornado Effect Pumps in Carrier Sewage Systems

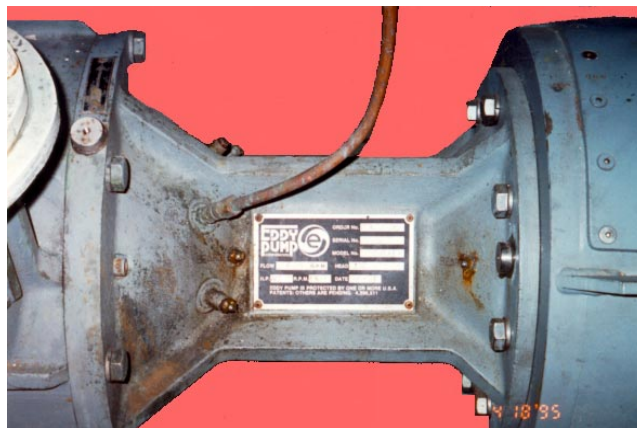
Figure 16. View of Eddy Pump showing location of fittings.

The pump was reassembled with a new shaft/bearing assembly (Figure 13). The shaft is inserted from the rear of the housing (Figure 14). A new seal assembly was then installed (Figure 15). This step revealed a machining problem with the bearing housing. The cone shaped seal assembly is inserted into the front of the bearing housing. The seal assembly has four threaded holes, which align exactly with corresponding non-threaded holes in the housing. These holes are for the four air and grease fittings (Figure 16 and Items 11 and 12 of Figure 3). Upon seal installation, the holes were found to be misaligned by about one-half degree, which was enough to prevent the fittings installations. Another seal assembly was tried, but the same problem

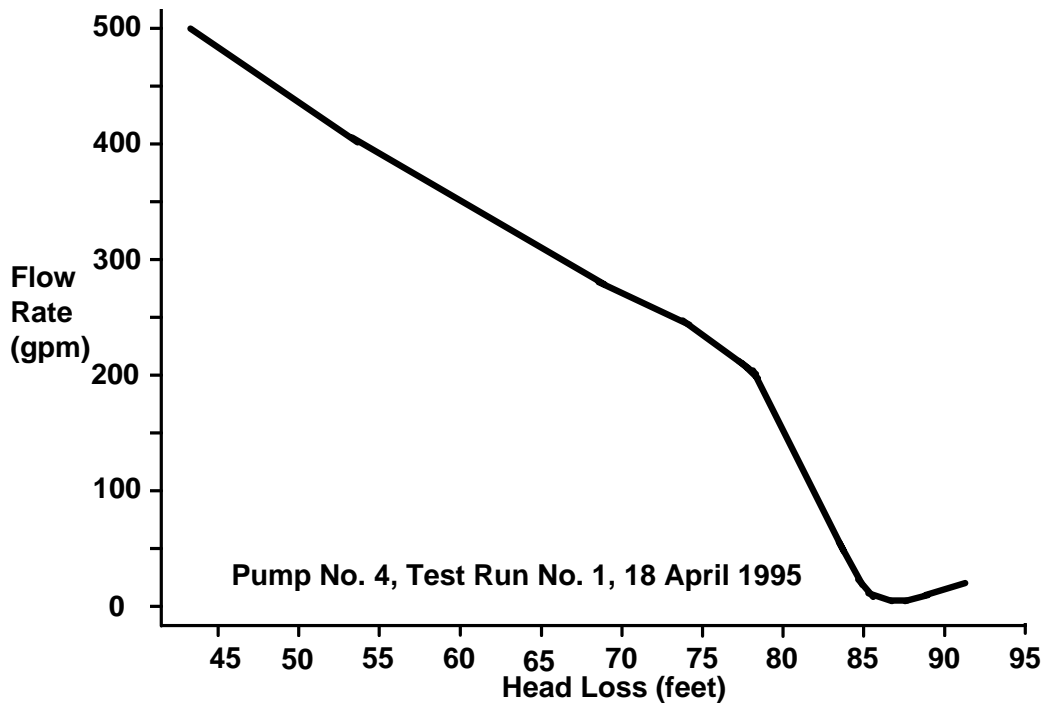
Figure 19. Pump head loss curve Run No. 1.

System friction losses from the pump to deck connection are shown in Figures 19 and 20. Only the average pump discharge gage values were used (rather than the range of readings) to generate these curves. Overall, losses decreased with increasing flow rate. This is because higher flows allow more of the pump's energy to be delivered to the deck connection. At lower flows, more energy (in the form of discharge pressure) builds up at the pump while downstream pressure eventually decreases to zero. The main source of losses at low flows is, of course, the discharge valve as it is progressively closed. The losses determined at full flow are acceptable for this CHT system configuration and Eddy Pump combination since deck connection pressures were adequate. Considering aircraft carrier CHT pump discharge piping configurations as a typical worst case scenario, the pump should provide adequate pressure at the deck connections for most, if not all, currently installed CHT systems.
